**Flood Control Project Maintenance
Levee Inspections**

Fall 2018 Levee Maintenance Deficiency Summary Report

Sacramento River Basin

**Flood Control Project Maintenance
Levee Inspections****LMA District Cover Sheet
Fall 2018 Levee Inspection Results****Reclamation District No. 0349 Sutter Island**

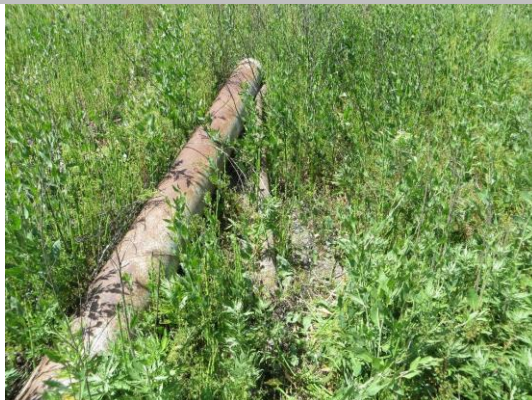
Photo 1 of 3 : UCIP_FA_2018_44391_73749.jpg

LM Start	5.19	Rating **	M	Issue No.	140
LM End	5.19	Issue Type +	En	Location *	
Category	Supplemental			GPS Latitude/Longitude	
				Start	End
Item	DWR UCIP Field Study			38.322460 °	38.322460 °
				-121.589690 °	-121.589690 °
DWR ID	24189				
Comment Code					
Inspector Comment					
FS_ID:44391 DS_ID:24189 EP_NO: N/A Repair Type: Non-Urgent Crossing Status: Found UCIP Comments: Appears abandoned and if so should be done so properly. FIELD_STRUCT_DESC: 4-inch irrigation pipe of unknown material through the levee, 3.3 feet below the crown. Gate and pump on platform at the landside (LS) toe (missing). Platform on the waterside (WS). [Additional Reference(s): DWR Levee Log, 2005. USACE Sacramento O&M Manual Unit No. 110, May 1959, revised 29 Dec 2016, (HLM 5.6)] FS Date: 4/9/2015

4-inch pipe next to larger pipe on LS slope.

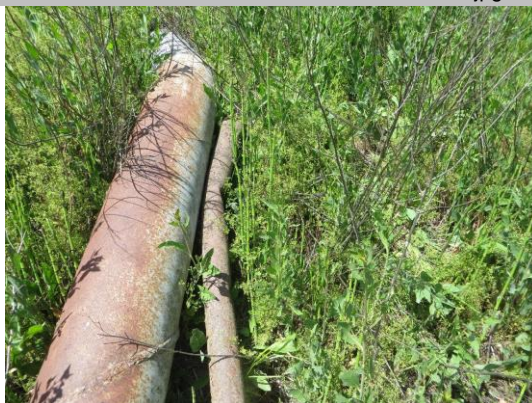
Photo 2 of 3 : UCIP_FA_2018_44391_73748.jpg

4-inch pipe next to larger pipe on LS slope.

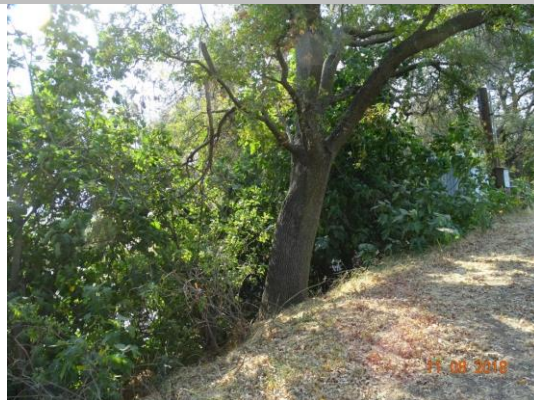
Photo 1 of 1 : FA_2018_RD0349_206_97_20181109_00086.jpg

LM Start	5.38	Rating **	U	Issue No.	97
LM End	5.38	Issue Type +	En	Location *	LS
Category	Earthen Levee			GPS Latitude/Longitude	
				Start	End
Item	Vegetation			38.323583 °	38.323583 °
				-121.586527 °	-121.586527 °
DWR ID	DWR_RD0349_03_f _ 2018_97				
Comment Code					
V6 : Landscaping					
Inspector Comment					
Thin fig trees

View of fig trees on the land side slope (November 2018).

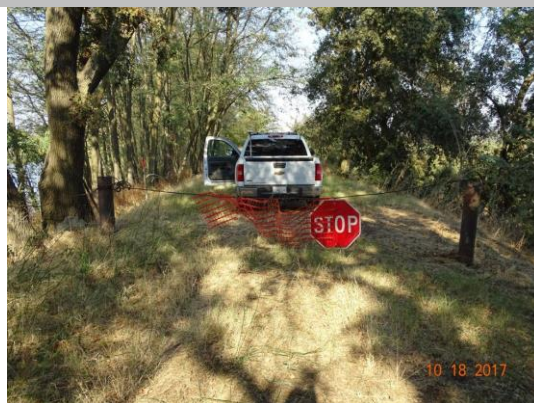
Photo 1 of 1 : FA_2018_RD0349_206_21_20180925_00002.jpg

LM Start	5.39	Rating **	U	Issue No.	21
LM End	5.39	Issue Type +	En	Location *	CR
Category	Earthen Levee			GPS Latitude/Longitude	
				Start	End
Item	Encroachments			38.323659 °	38.323659 °
				-121.586421 °	-121.586421 °
DWR ID	DWR_RD0349_03_f_2017_21				
Comment Code					
FE : Fence					
Inspector Comment					
Cable gates are banned. Must remove. No lock on this gate.

Cable gates are banned. Must remove. No lock on this gate.

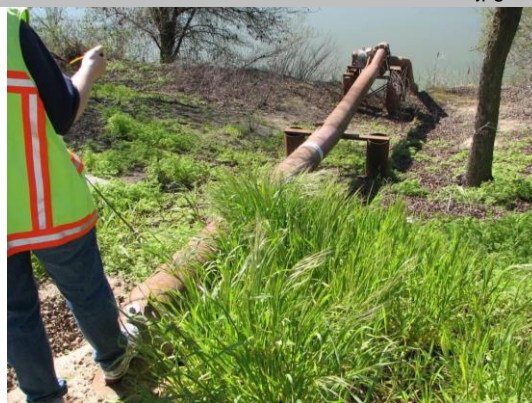
Photo 3 of 3 : UCIP_FA_2018_50016_36842.jpg

UCIP Comments: 8/22/2016 Crossing has been downgraded from Urgent to Non-Urgent no signs of pipe failure were present on levee crown or slopes during site visit. Need to contact owner to determine last internal inspection completed. (DWR UCIP - omagana)3/19/2009 Soil disturbed on landward slope--need to contact owner. Also vegetation limits the inspector's visibility to identify signs of pipe failure (leaks) along the slope. Recommend removing vegetation along pipe alignment to conduct proper inspection of structure and appurtenances. Note date on photos should be 3/18/09 not 7/26/08 camera metadata is incorrect. (DWR UCIP - omagana)

FIELD_STRUCT_DESC: 10-inch irrigation pipe of unknown material through the levee, 3.8 feet below the crown. Pump in pump house on waterside (WS). Service pole on WS slope. Concrete standpipe and distribution box located on the WS toe. Pipe is exposed on both slopes. Section of pipe under crown, between shoulders, removed and replaced with 10-inch steel pipe in November 20, 1991, no permit application was filed. In August 13, 1993, Mr. Steve Makis of Flood Management, revealed that the pipe was not soil proofed, and siphon breaker was not installed, and backfill was less than 90 % and less than 2-foot of cover through the levee crown. Pipe was required to be completely removed and replaced in September 15, 1993. (10-inch authorized under Permit No. 16077, 1993 - John McCormack Company, 10-inch pipe replaces the USACE O&M 10-inch pipe referenced as HLM 5.9) [Additional Reference(s): DWR Levee Log, 2005. USACE San Joaquin O&M Manual Unit No. 110, May 1959, HLM 5.9, Drawing not available]. FS Date: 8/17/2016

View of WS.

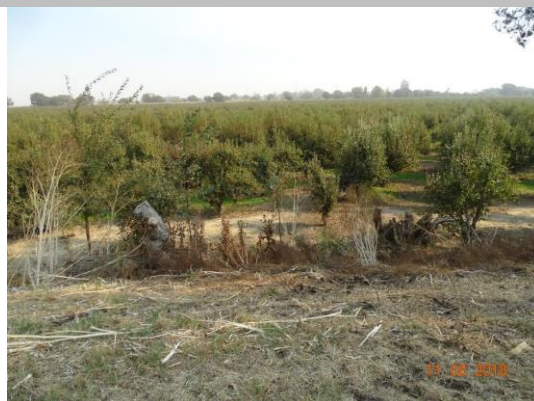
Photo 1 of 1 : FA_2018_RD0349_206_95_20181109_00085.jpg

LM Start	5.71	Rating **	M	Issue No.	95
LM End	5.71	Issue Type +	Ma	Location *	LS
Category	Earthen Levee			GPS Latitude/Longitude	
				Start	End
Item	Encroachments			38.327828 °	38.327828 °
				-121.584960 °	-121.584960 °
DWR ID	DWR_RD0349_03_f_2018_95				
Comment Code					
TR : Tree or limb					
Inspector Comment					
Remove down trees from land side slope

View of down trees on the land side slope (November 2018).

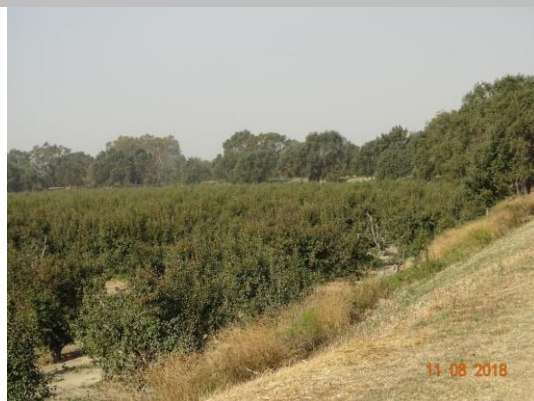
Photo 1 of 1 : FA_2018_RD0349_206_92_20181109_00084.jpg

LM Start	5.88	Rating **	M	Issue No.	92
LM End	5.88	Issue Type +	Ma	Location *	LS
Category	Earthen Levee			GPS Latitude/Longitude	
				Start	End
Item	Vegetation			38.330110 °	38.330110 °
				-121.584628 °	-121.584628 °
DWR ID	DWR_RD0349_03_f_2018_92				
Comment Code					
V1 : Control annual grass and weeds on the levee slopes and easements.					
Inspector Comment					
Remove vegetation all the way down to land side toe

View looking upstream at vegetation partway down the land side slope (November 2018).

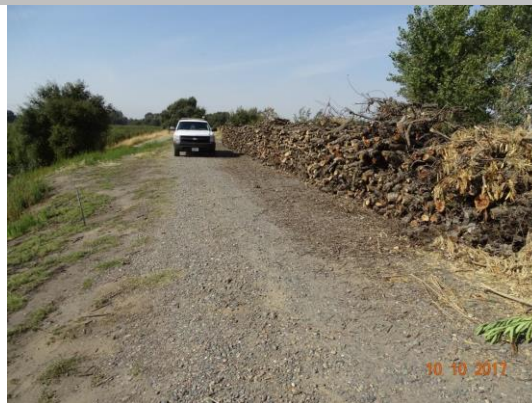
Photo 1 of 1 : FA_2018_RD0349_206_36_20180925_00004.jpg

LM Start	6.33	Rating **	U	Issue No.	36
LM End	6.39	Issue Type +	En	Location *	CR
Category	Earthen Levee			GPS Latitude/Longitude	
				Start	End
Item	Encroachments			38.328844 °	38.328100 °
				-121.579075 °	-121.578310 °
DWR ID	DWR_RD0349_03_f_2017_36				
Comment Code					
FW : Firewood					
Inspector Comment					
130-foot-long, 6-foot-high stack of firewood on waterside of crown will inhibit ability to flood fight. Should be removed.

Firewood on crown/waterside shoulder at LM 6.35.

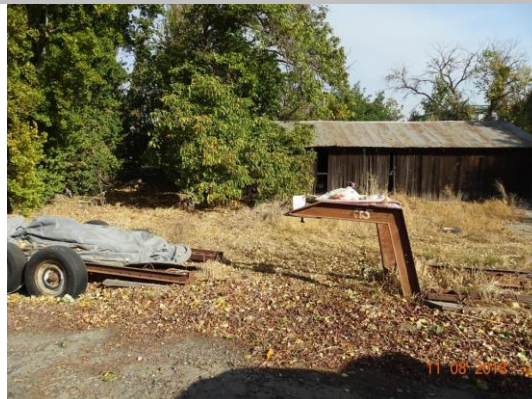
Photo 1 of 1 : FA_2018_RD0349_206_65_20181109_00081.jpg

LM Start	6.47	Rating **	M	Issue No.	65
LM End	6.47	Issue Type +	En	Location *	WS
Category	Earthen Levee			GPS Latitude/Longitude	
				Start	End
Item	Encroachments			38.327287 °	38.327287 °
				-121.577333 °	-121.577333 °
DWR ID	DWR_RD0349_03_f_2018_65				
Comment Code					
EQ : Equipment					
Inspector Comment					
Remove equipment from water side slope

View of trailer and other equipment on the water side shoulder (November 2018).
